## WHEN A TENDON IS BLOCKED

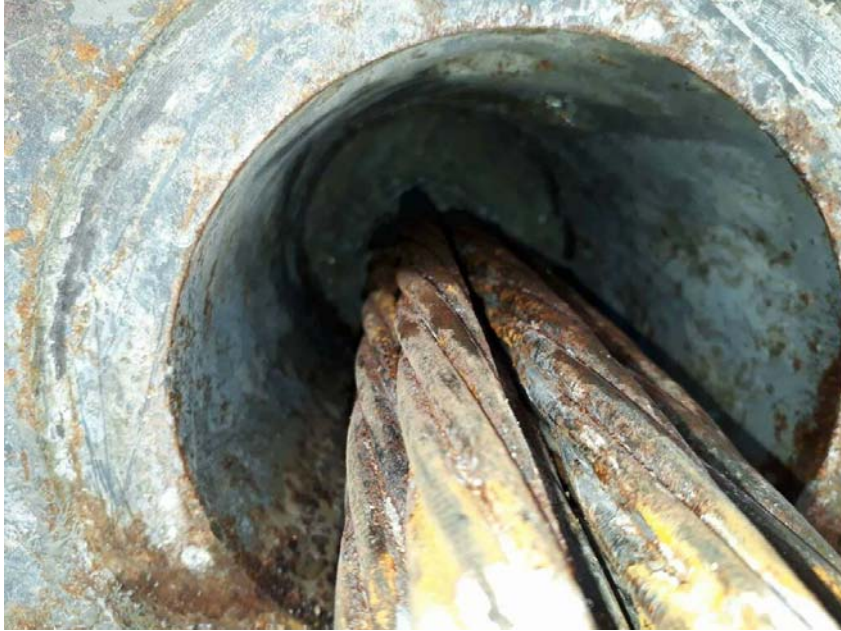
**b. Concrete penetration inside the trumpet (bearing plate):**

During anchor head installation you will witness that the area inside the bearing plate is blocked.

**Photo of a blocked tendon in anchorage area**

**PHASE A:**

Follow 3.a.PHASE A

**PHASE B:**

Try to investigate the length of this blockage. Use a long chisel or drill and demolish concrete avoiding any damage to the strands. Try as deeper and far as you can. Repeat 3.a.PHASE A above. If still blocked, that means the concrete has covered a considerable length beyond the trumpet. Follow 3.a.PHASE B as above.

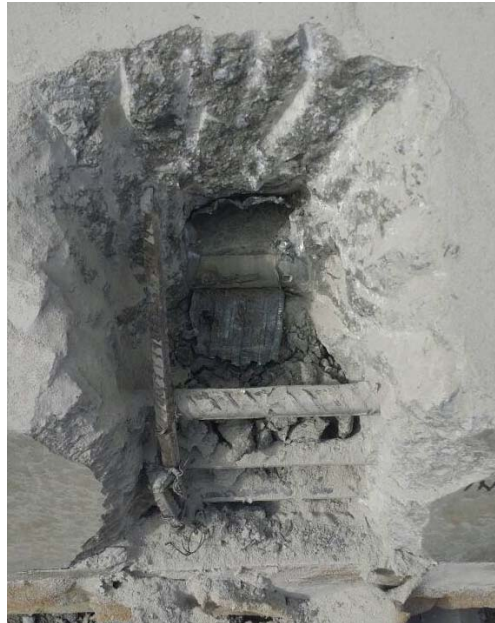
**Photo of demolished area exposing sheath**

By calculating the theoretical operational length L (as described above 2.a), initiate local demolition works at that area. Carefully remove concrete without cutting or damage the reinforcement till you reach the duct. Use a long chisel or drill and demolish concrete avoiding any damage to the strands. Drill a small hole/opening on the duct carefully without damaging strands so as to check if the tendon is blocked. Continue small drillings along the tendon till you find the unblocked area. Cut the sheath's wall carefully without damaging strands. The process is time consuming and difficult since the access (for tools and hands is limited). Remove concrete debris as much as you can. Use a long chisel and a sledge hammer. Upon completion use an air blower and remove dust, filths and other foreign objects. Put a piece of duct (same material with the installed sheath) covering the cut area of sheath. This piece must have dimensions slightly larger than the cut area. Apply carefully stucco or pasta to seal the sheath's patch avoiding any opening. Finally use a strong epoxy resin to fill all the demolished area (follow manufacturer's instructions).
