Blocked Tendon

How can we realize that a tendon is blocked and if yes what shall we do?

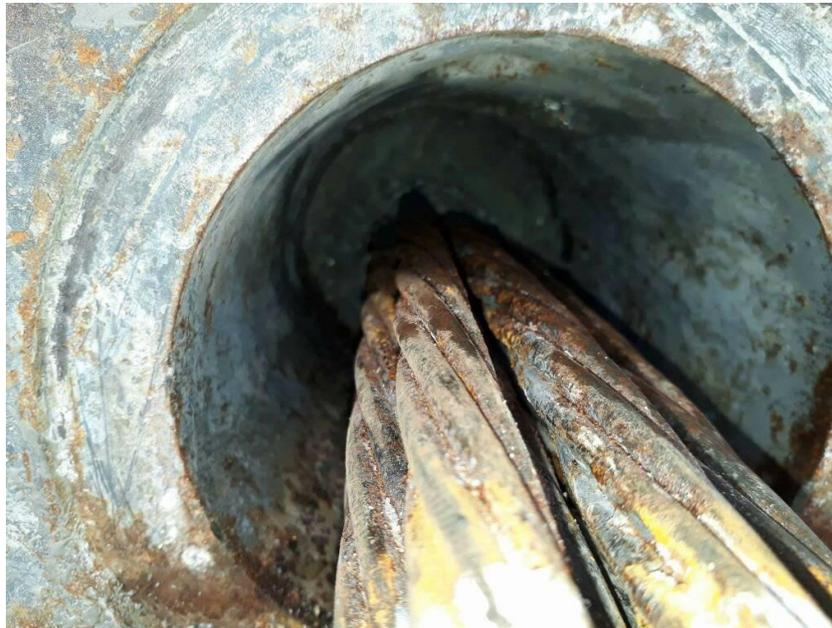
b. Concrete penetration inside the trumpet (bearing plate):

During anchor head installation you will witness that the area inside the bearing plate is blocked.

Photo of a blocked tendon in anchorage area

PHASE A:

Follow above SOLUTION a.PHASE A

PHASE B:

Try to investigate the length of this blockage. Use a long chisel or drill and demolish concrete avoiding any damage to the strands. Try as deeper and far as you can. Repeat above SOLUTION a.PHASE A. If still blocked, that means the concrete has covered a considerable length beyond the trumpet. Follow above SOLUTION a.PHASE B.

PHASE C:

Follow above SOLUTION a.PHASE C

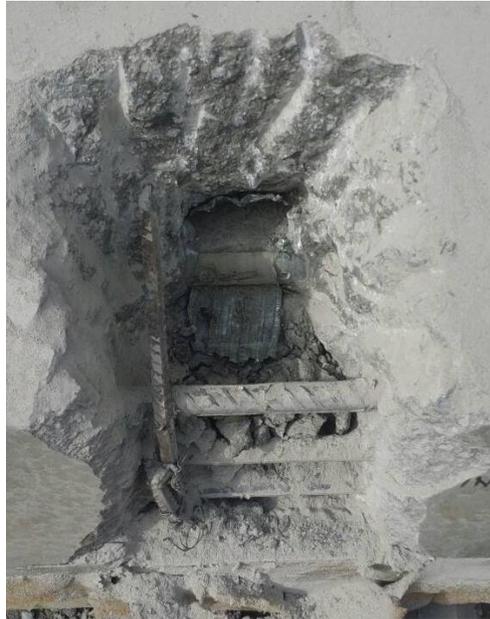
Photo of demolished area exposing sheath

By calculating the theoretical operational length L (as described above 2.a), initiate local demolition works at that area. Carefully remove concrete without cutting or damage the reinforcement till you reach the duct. Use a long chisel or drill and demolish concrete avoiding any damage to the strands. Drill a small hole/opening on the duct carefully without damaging strands so as to check if the tendon is blocked. Continue small drillings along the tendon till you find the unblocked area. Cut the sheath's wall carefully without damaging strands. The process is time consuming and difficult since the access (for tools and hands is limited). Remove concrete debris as much as you

can. Use a long chisel and a sledgehammer. Upon completion use an air blower and remove dust, filths and other foreign objects. Put a piece of duct (same material with the installed sheath) covering the cut area of sheath. This piece must have dimensions slightly larger than the cut area. Apply carefully stucco or pasta to seal the sheath's patch avoiding any opening. Finally use a strong epoxy resin to fill all the demolished area (follow manufacturer's instructions).
